# Safety Inspection Report

Annual Inspection

## Quenington Playground

Quenington Parish Council

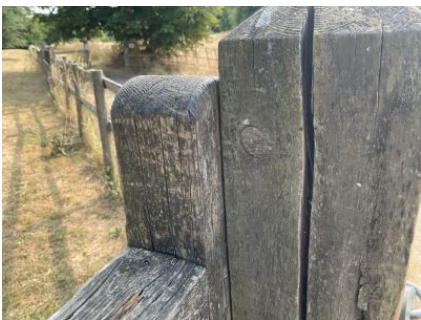
There is a crushing or shearing point on the side of the gate. Where the gaps reduce to less than 12 mm these have been known to cause serious, permanent injury to children, especially on the hinge side where the leverage forces are significant.

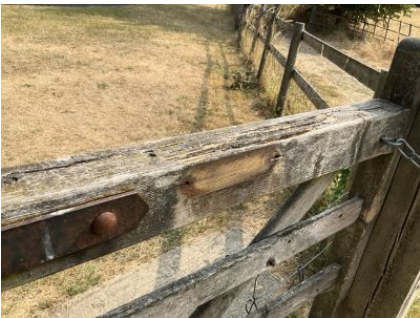
Timber is decayed.

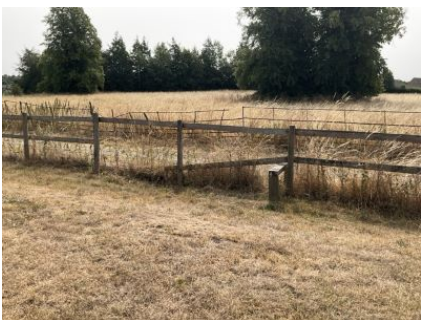
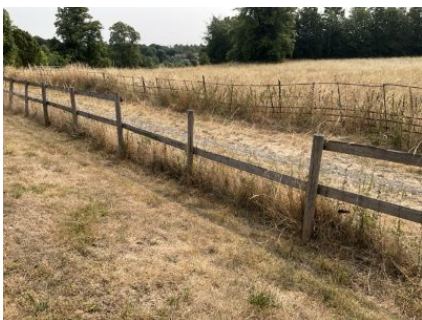
Moderate repairs are needed.

Repair.

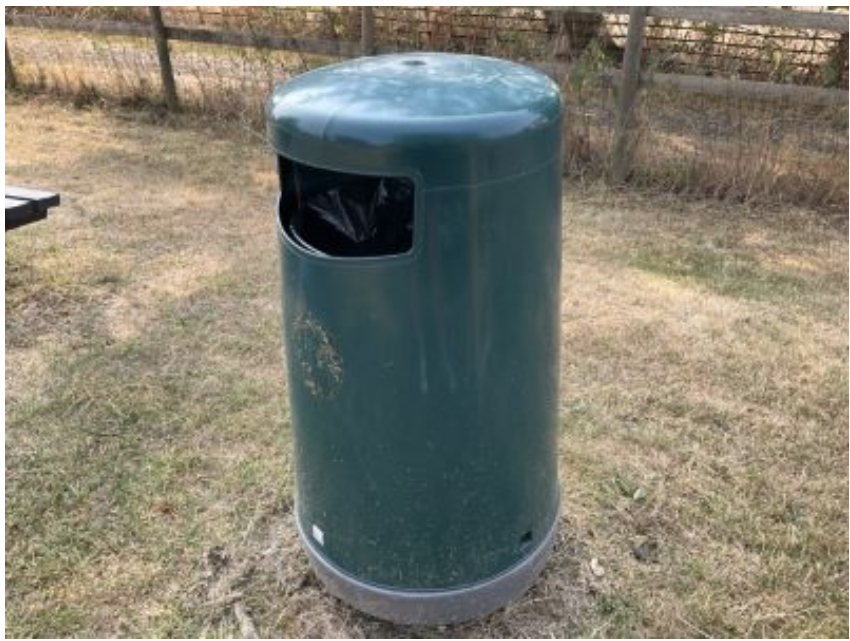
Item is cracked.

Monitor and plan for replacement.

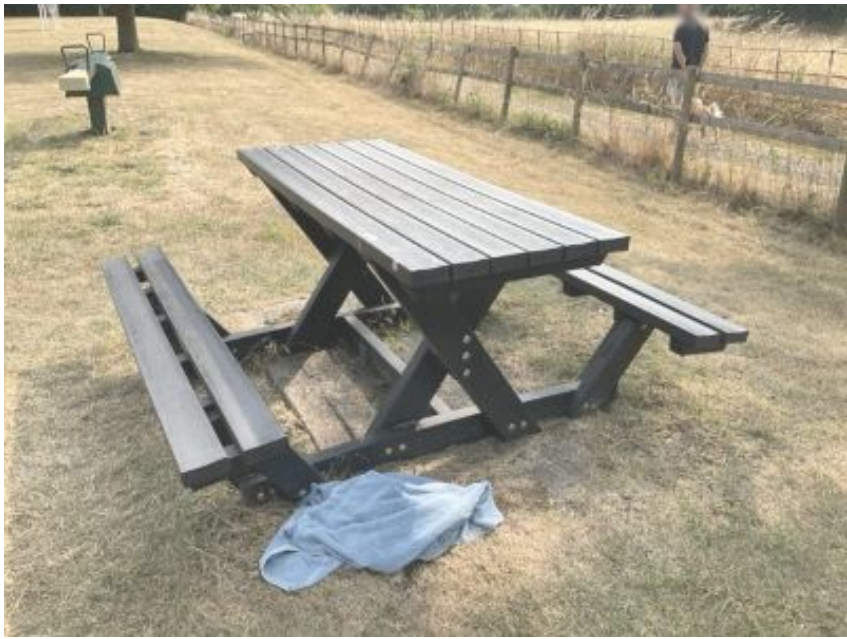
| Description |
|---|
| Cap missing. |

| Description |
|---|
| Replace. |

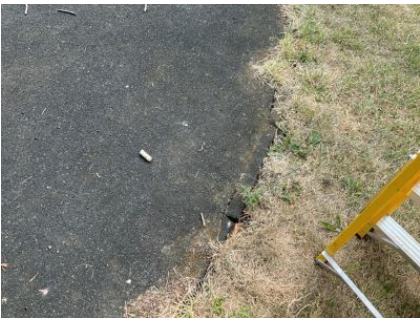
Shrinkage / separation of the surface. This may give a trip hazard.

Repair.

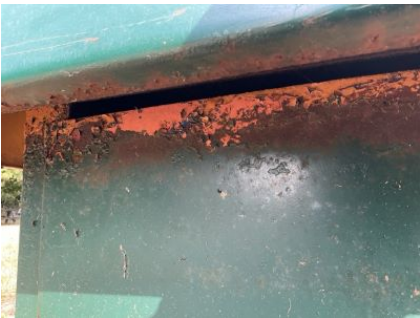
Item has corrosion.

Treat and repair.

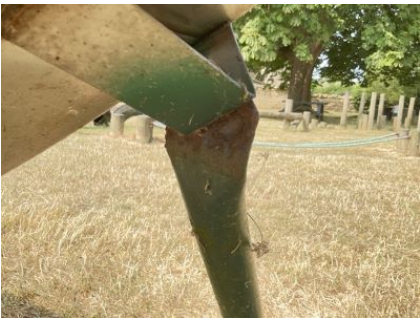
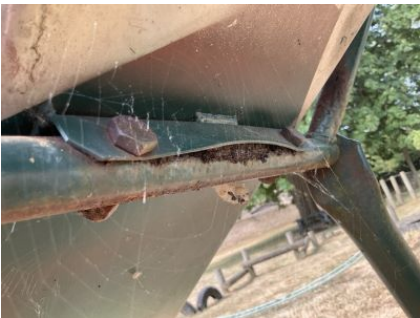
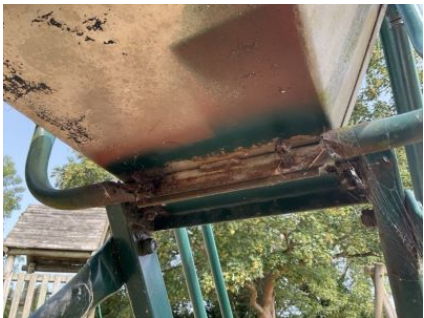
Item has corrosion.

Replace.

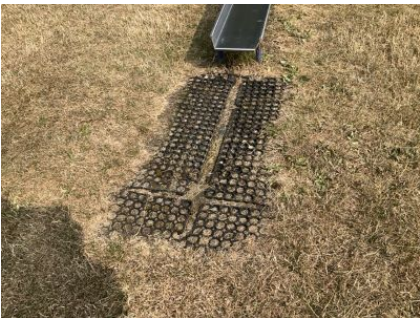
Surface needs repair.

Repair.

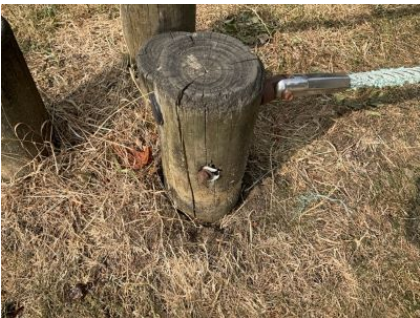
Cap missing.

Replace.

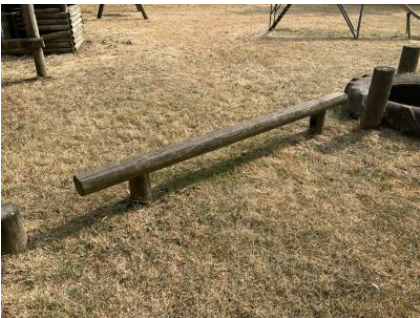
Loose in ground.

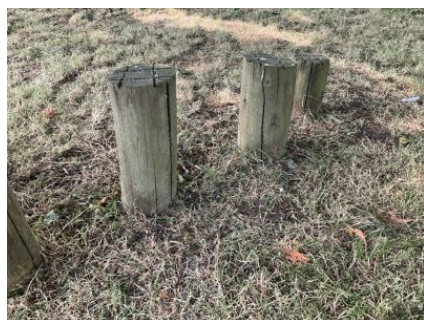
Timber is decayed.

Varying levels of decay throughout. Majority are early signs of decay.

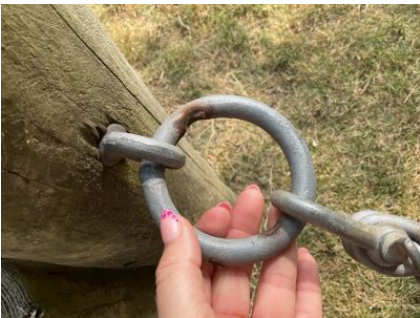
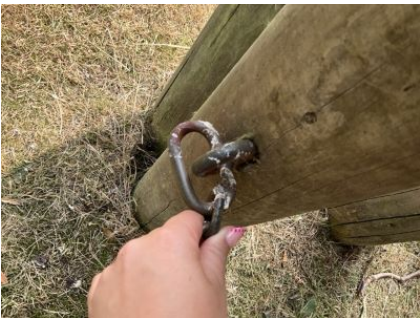
Some chain wear.

Monitor for further deterioration and replace before 40% wear.

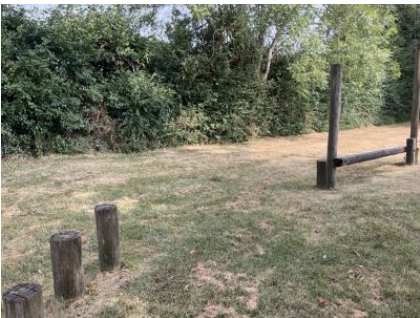
Missing item.

Replace.

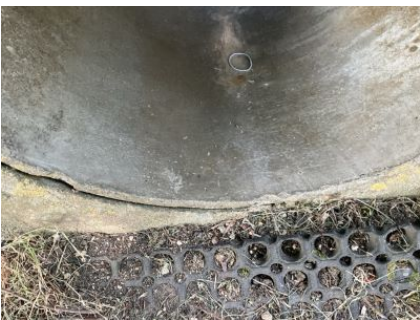
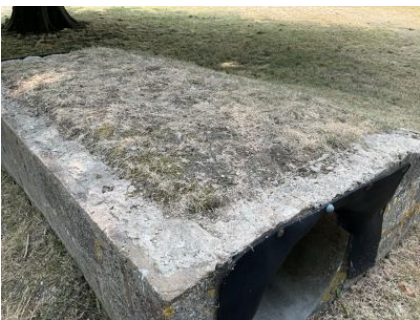
Concrete edges are in poor condition.

Repair.

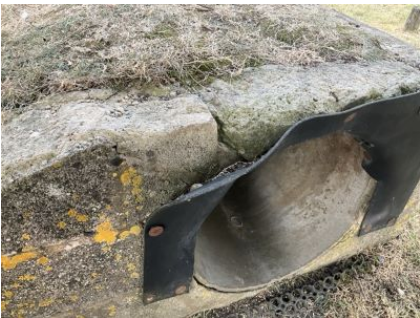
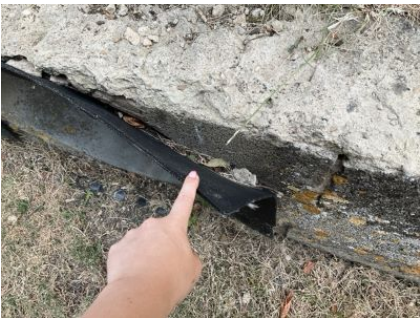
Fixtures loose or missing.

Tighten/replace.

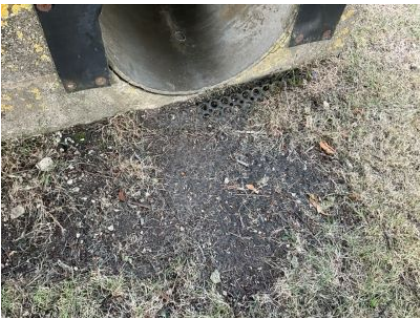
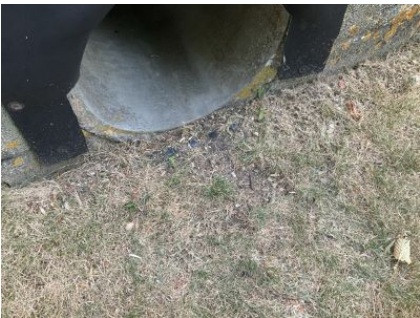
Surface is wearing.

Replace.

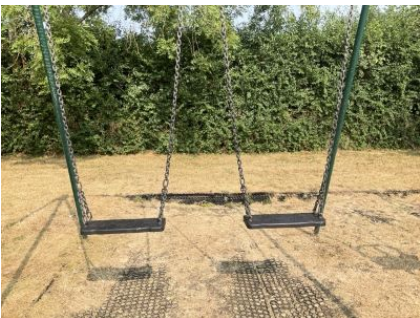
The safer surface has hard edging / foundation within the impact area.

Grass matting has been used to cover but it is broken.

Modify to remove the hazard.

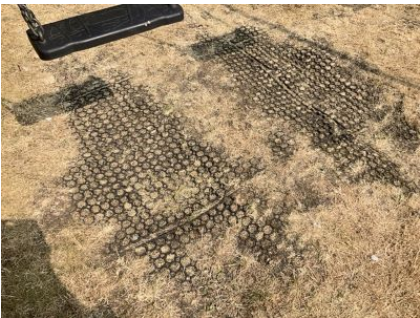
Surface is wearing.

Replace.

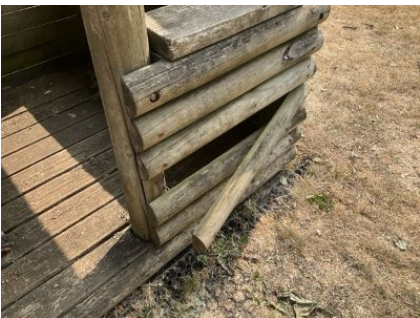
Fixtures loose or missing.

Tighten/replace.

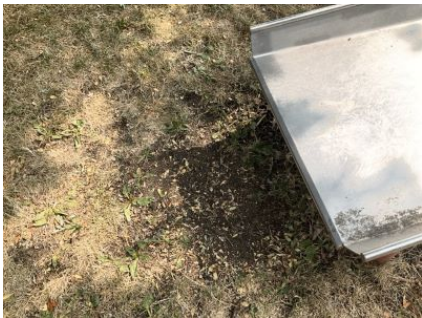
Surface is wearing.

Monitor for significant deterioration and rectify when necessary.

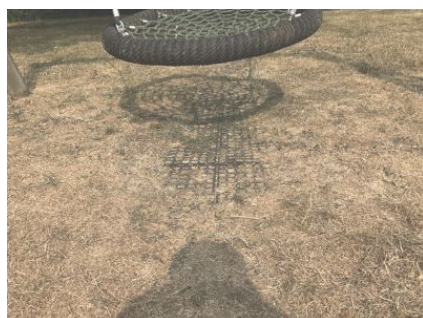
Surface is wearing.

Monitor for significant deterioration and rectify when necessary.

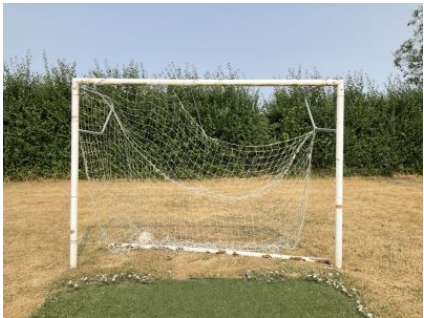
Moderate repairs are needed.

Posts x 2 unattached and nets need to be repaired.
