# Safety Inspection Report

Annual Inspection

## Quenington Playground

Quenington Parish Council

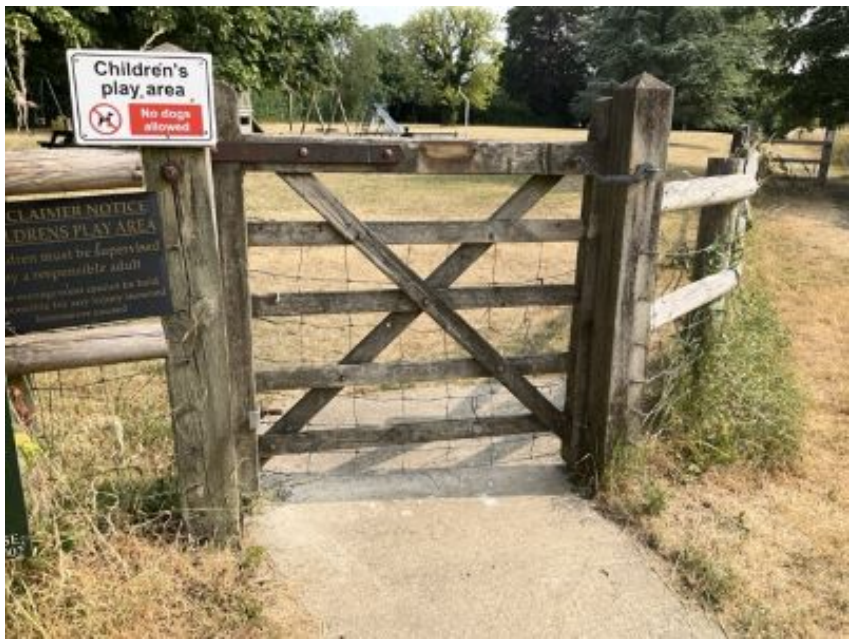
# Gates

There is a crushing or shearing point on the side of the gate. Where the gaps reduce to less than 12 mm these have been known to cause serious, permanent injury to children, especially on the hinge side where the leverage forces are significant.

Timber is decayed.

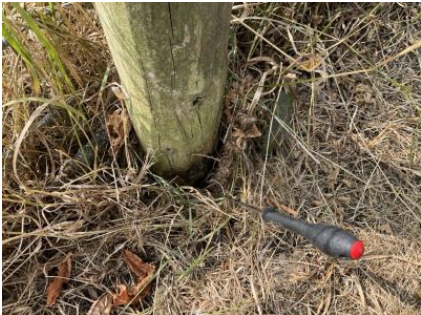
Timber is decayed.

Replace affected parts.

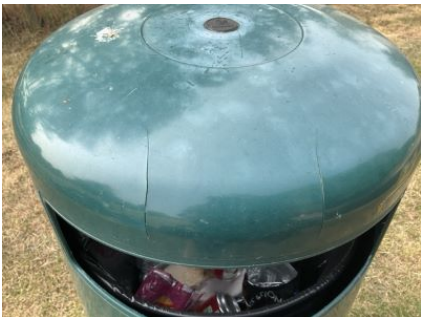
Item is cracked.

Monitor and plan for replacement.

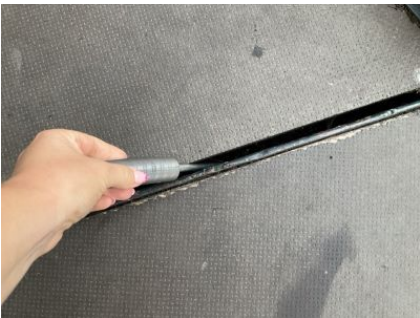
Shrinkage / separation of the surface. This may give a trip hazard.

Repair.

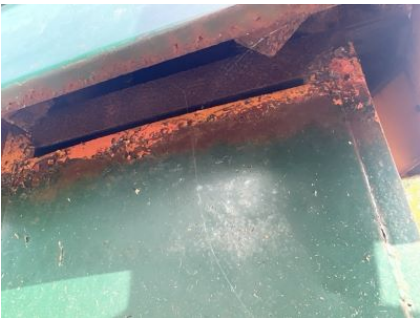
Item is cracked.

Monitor and plan for replacement.

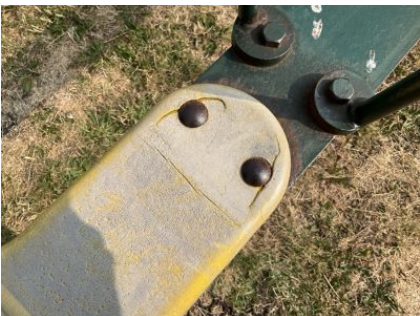
Item has corrosion.

Treat and repair.

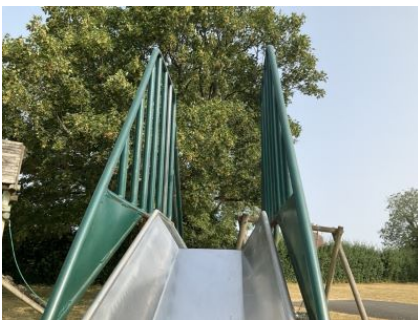
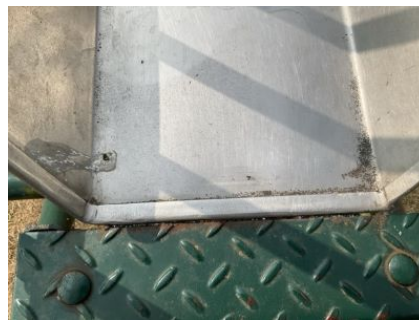
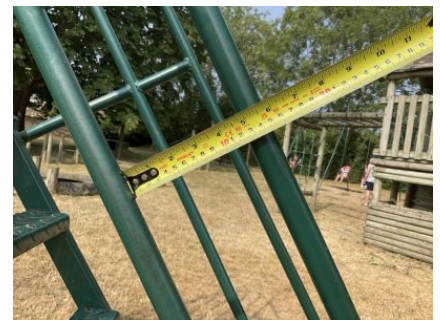
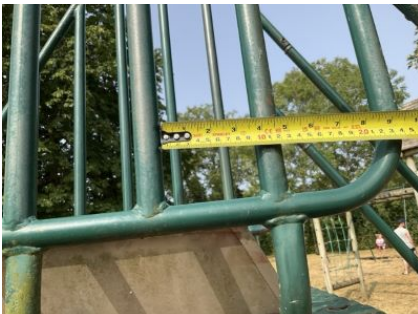
Item has corrosion.

Surface needs repair.

Replace.

Repair.

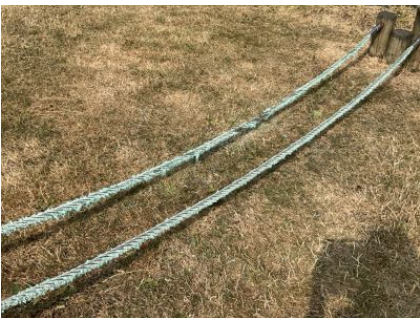
Timber is decayed.

Varying levels of decay throughout. Majority are early signs of decay.

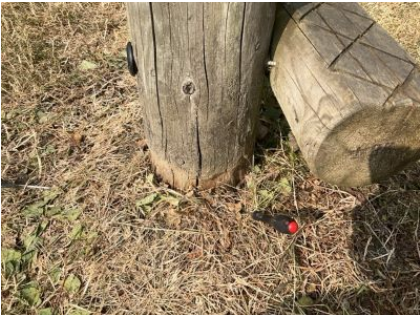
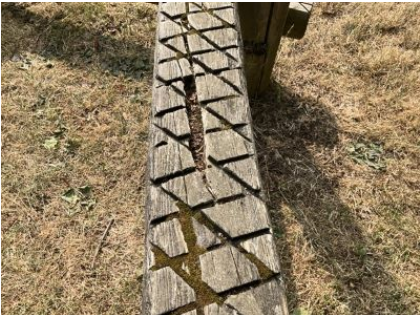
Strimmer damage is present on posts, allowing water to enter and timbers to soften. It can also remove the protective envelope around the timber. Prevent further damage and check timbers for decay throughout the year.

Prevent further damage.

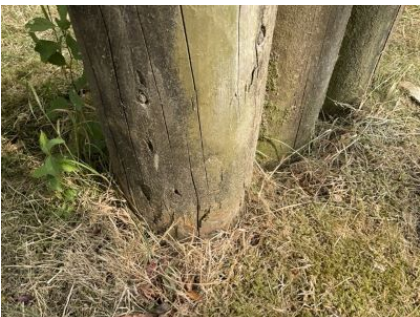
Strimmer damage is present on posts, allowing water to enter and timbers to soften. It can also remove the protective envelope around the timber. Prevent further damage and check timbers for decay throughout the year.

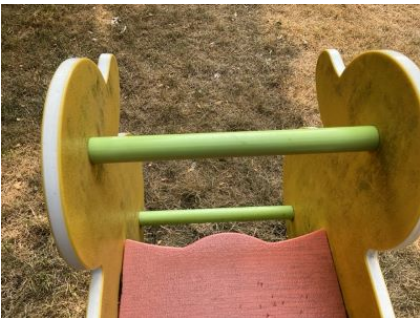
1. Cap missing.

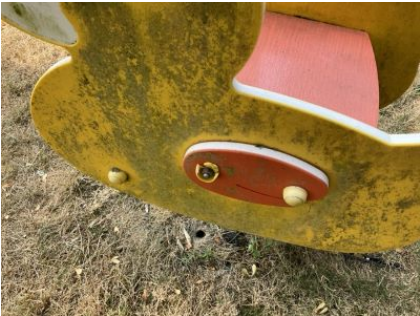
Cap missing.

Replace.

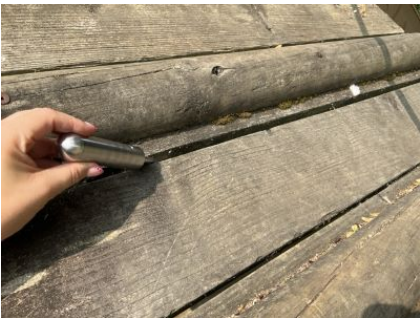
1. Fixtures loose or missing.
2. Surface is wearing.
3. Exposed metal rope core(s).
4. Item is damaged.
5. Strimmer damage is present on posts, allowing water to enter and timbers to soften. It can also remove the protective envelope around the timber. Prevent further damage and check timbers for decay throughout the year.

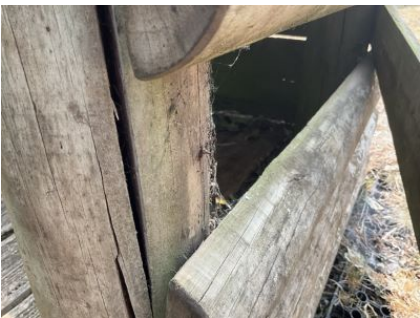
Fixtures loose or missing.

Tighten/replace.

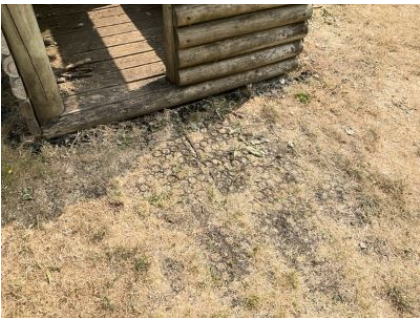
Surface is wearing.

Monitor for significant deterioration and rectify when necessary.

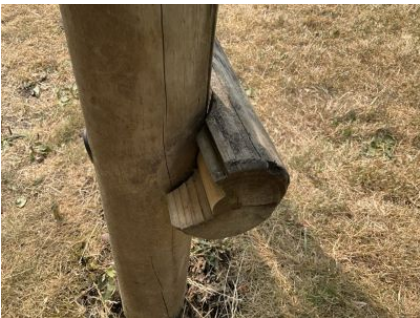
Item is damaged.

Monitor for significant deterioration and repair/replace as necessary.

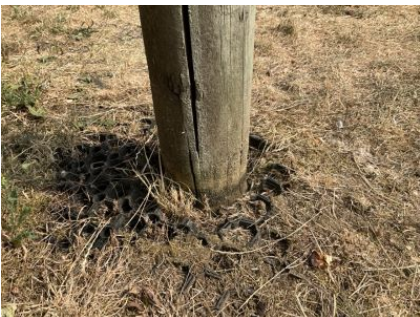
Strimmer damage is present on posts, allowing water to enter and timbers to soften. It can also remove the protective envelope around the timber. Prevent further damage and check timbers for decay throughout the year.

Prevent further damage.

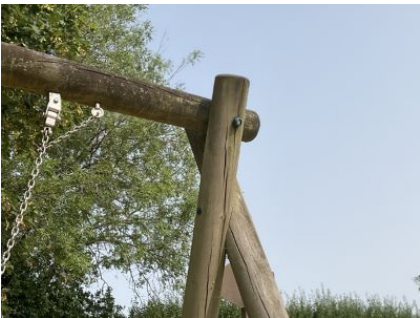
Cap missing.

Replace.

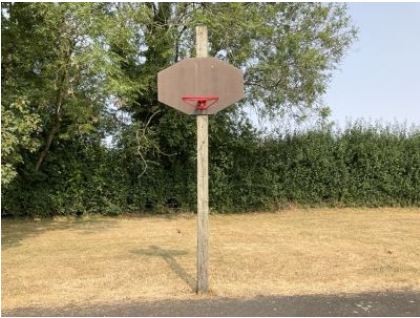
A clearly visible sign must be fitted to all sports related equipment with at least the following: a) equipment is not intended for children less than 36 month, b) "Do not climb on the framework or nets", c) "Do not hang on the ring", d) "Do not wear rings or other jewellery as these can get caught and cause injury", e) name and telephone number of site owner, f) number to call in case of accident.

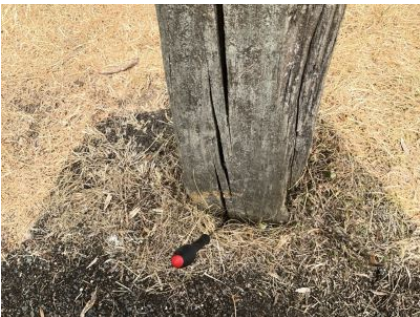
Timber is decayed.

Replace affected parts.

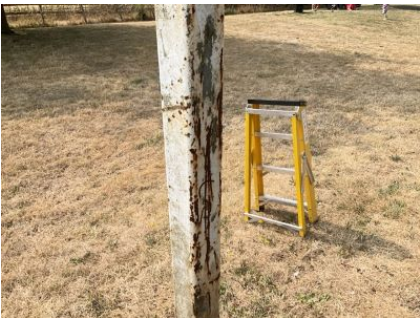
Item has corrosion.

Treat and repair.

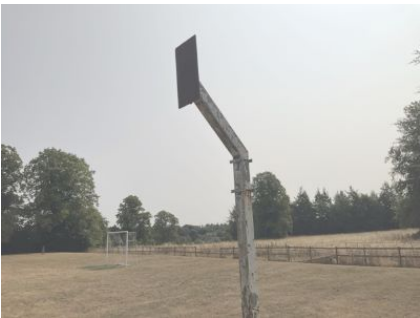
Item has some parts missing.

Replace the missing parts.

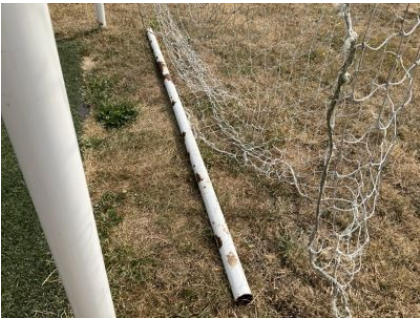
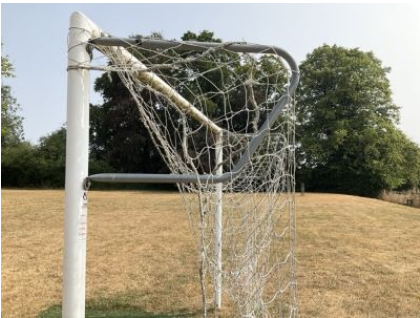
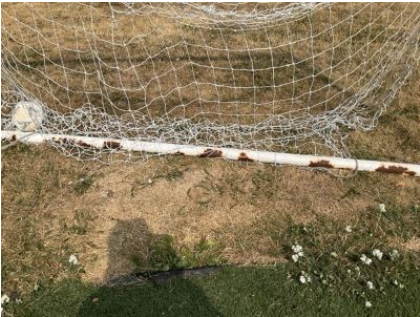
Moderate repairs are needed.

Posts x 2 unattached and nets need to be repaired.
